ESL-TR-91-35

**DAMAGE OF CONCRETE PARKING  
APRONS FROM AUXILIARY POWER  
UNIT (APU) EXHAUST AND SPILLED  
JET OILS**

**HEADQUARTERS AIR FORCE CIVIL  
ENGINEERING SUPPORT AGENCY  
AIR BASE OPERABILITY AND REPAIR  
BRANCH**

**APRIL 1992**

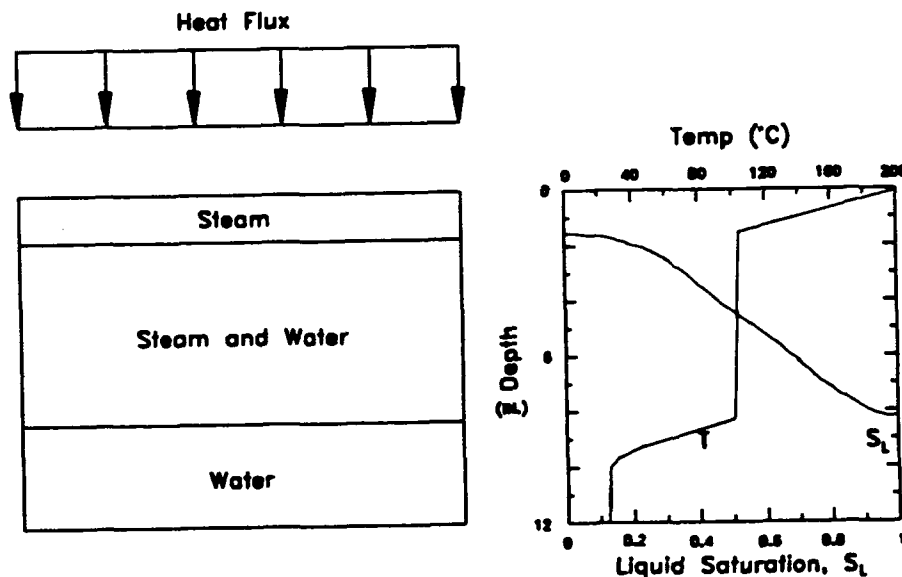
Figure 8 Temperature and Liquid Saturation in a Concrete Slab under a Heat Flux (11)

With the application of APU heat, the free moisture in the top 1/4 to 1/2 inch of the concrete slabs is driven out (upward and downward). This is supported by Figure 8 which shows the liquid saturation in rock exposed to a radiation heat source. After the heat is

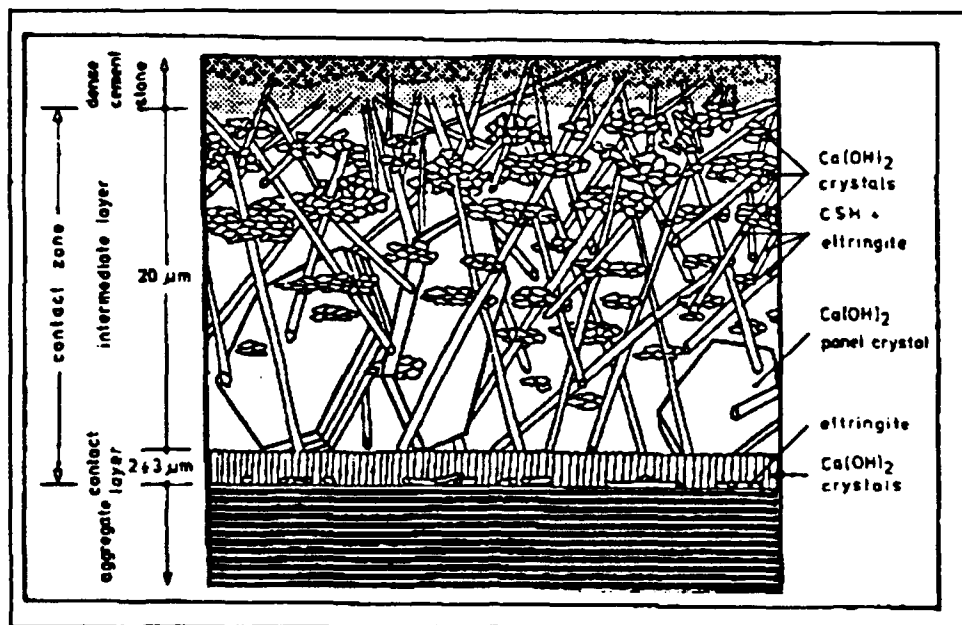
Figure 9 Model of Paste-Aggregate Interface

Figure 9 illustrates the contact between the cement mortar (calcium silicate hydrate) and the aggregate in an early stage of the hydration process (8). With time and increased hydration, the intermediate layer is overlapped by more of the panel-shaped calcium hydroxide crystals and the cement mortar. Zimbelmann (8) states that the load transfer between the cement mortar and the aggregate is provided mainly by the large hexagonal platelets of calcium hydroxide  $[Ca(OH)_2]$ .

Both the contact layer around the aggregate and the large platelets of calcium hydroxide are being consumed in the hydrolysis process.
